Robson Lapina

Forensic Engineers, Architects, Scientists & Fire Investigators

GABRIEL G. ALEXANDER, P.E.
Mechanical Engineer

Post incident inspection of the vehicle revealed that the lower safety cable above the cab on the driver's side had failed.

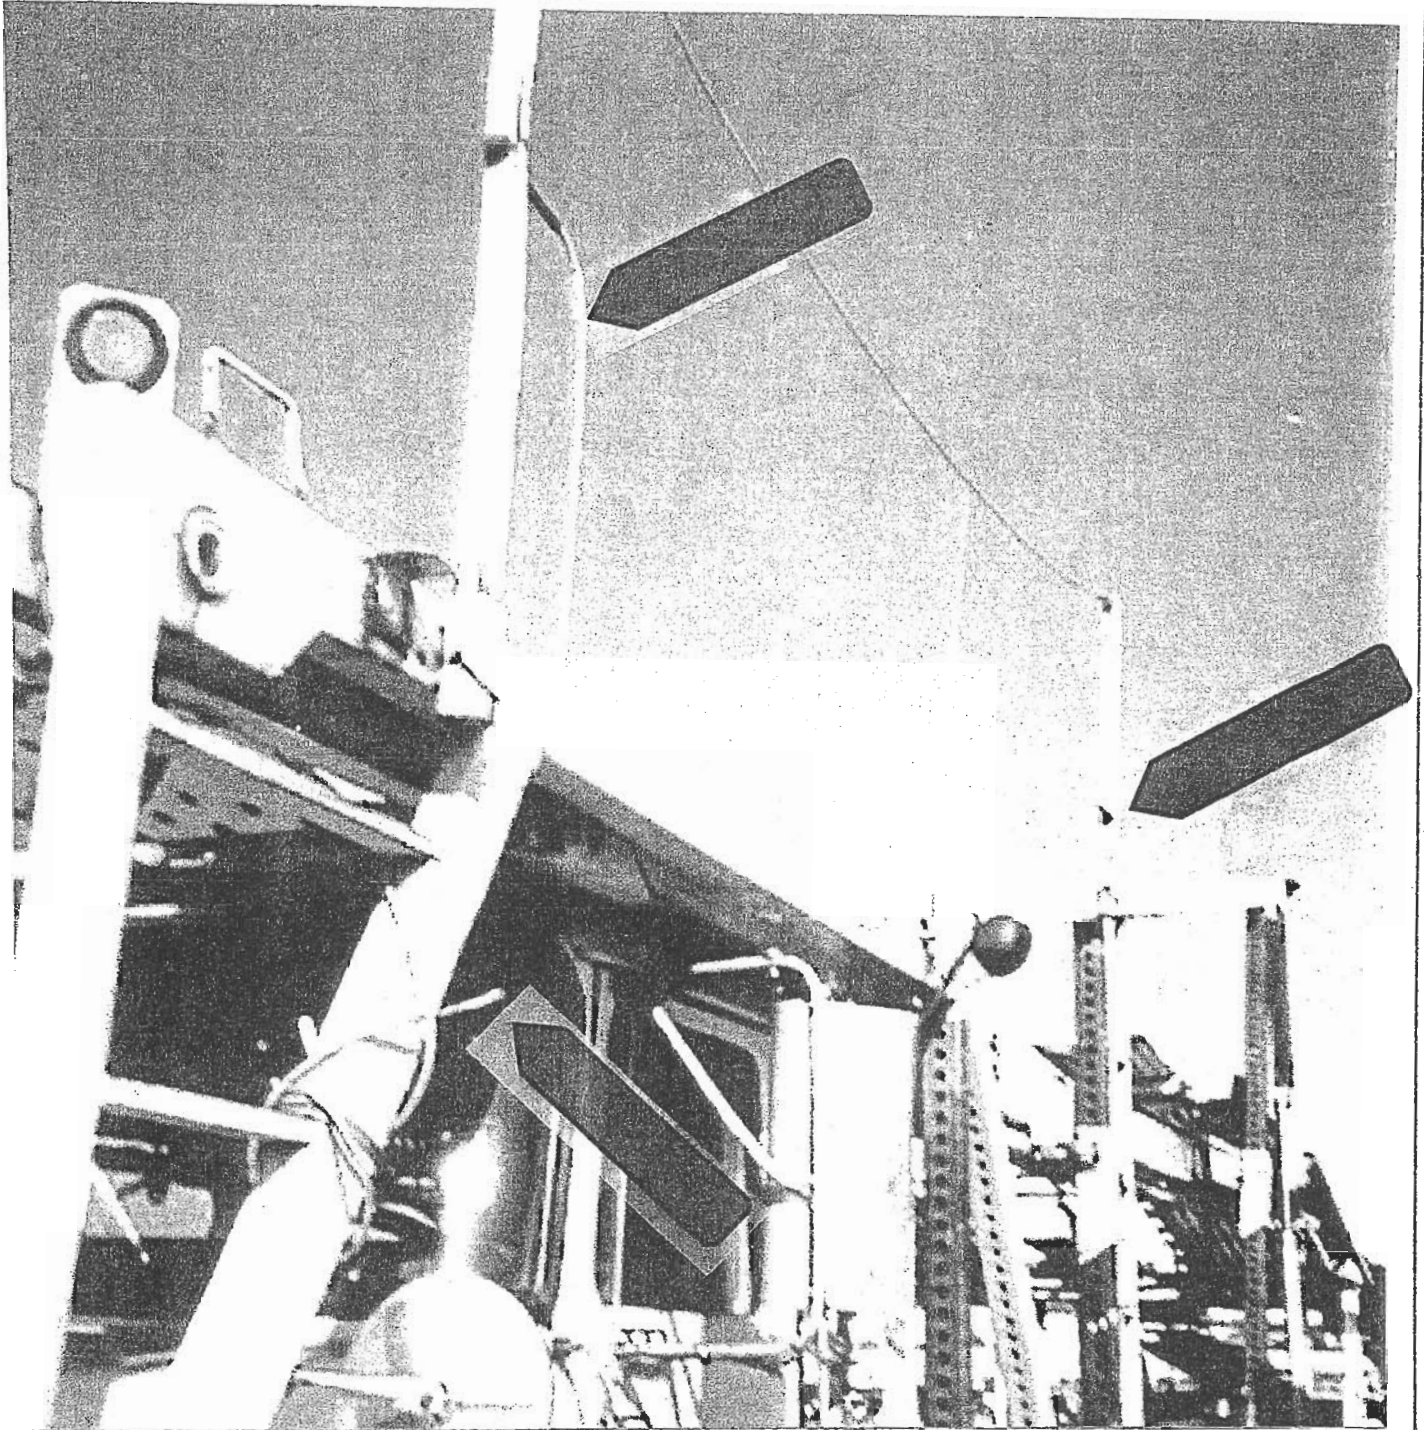
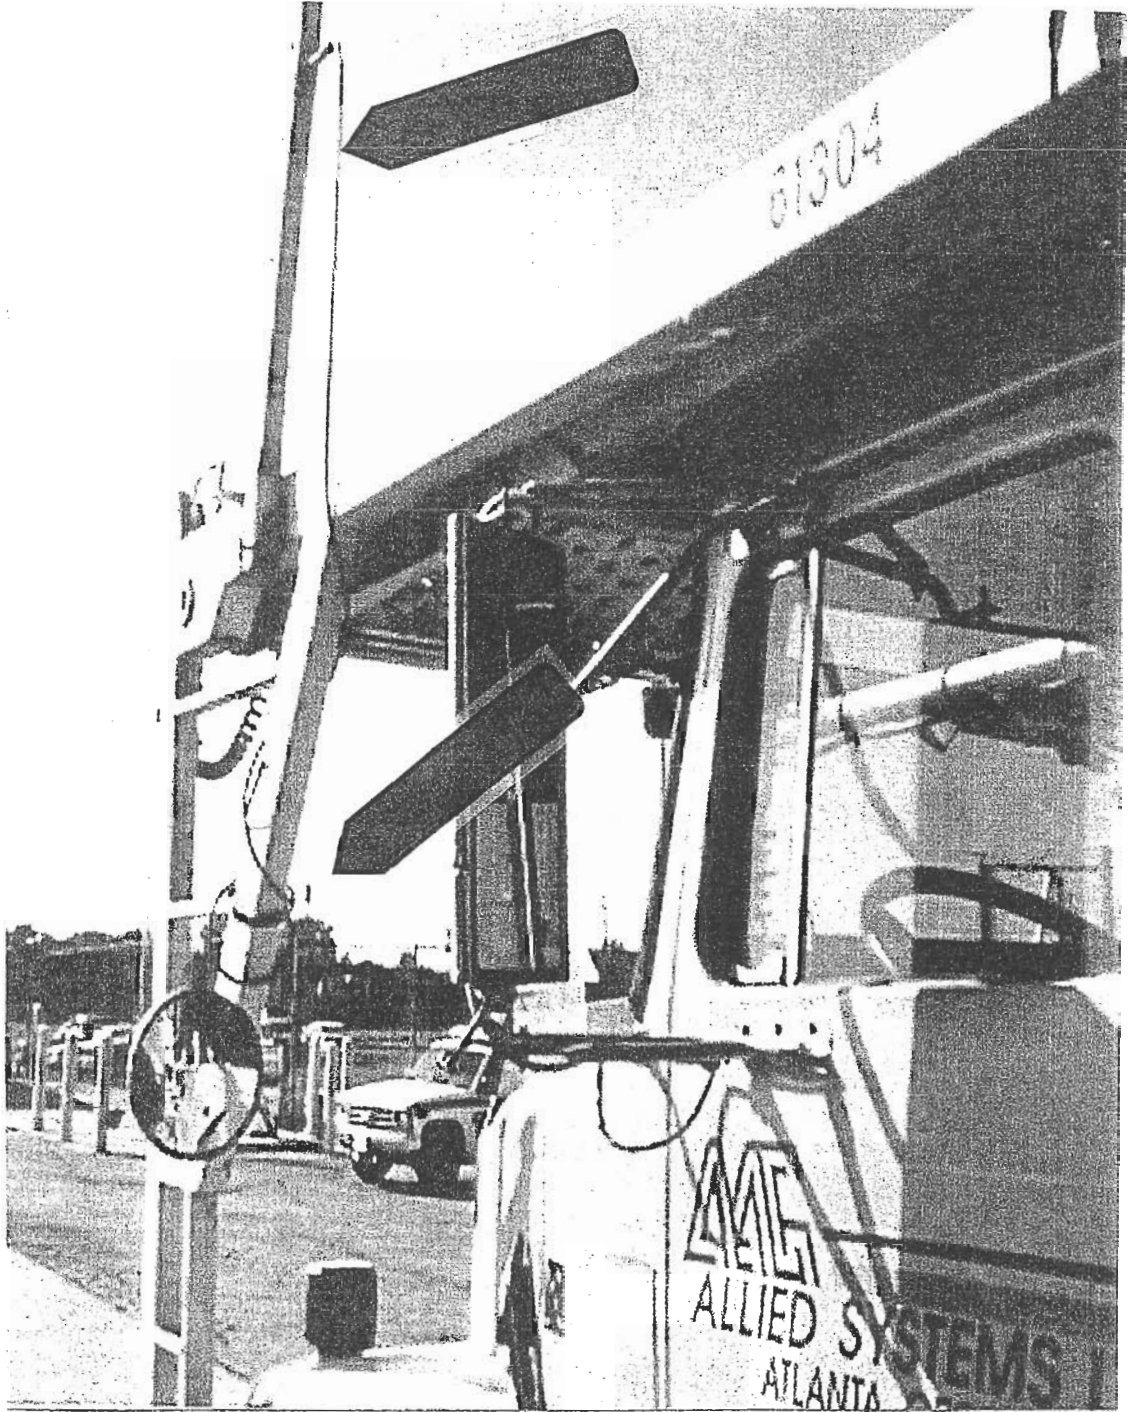
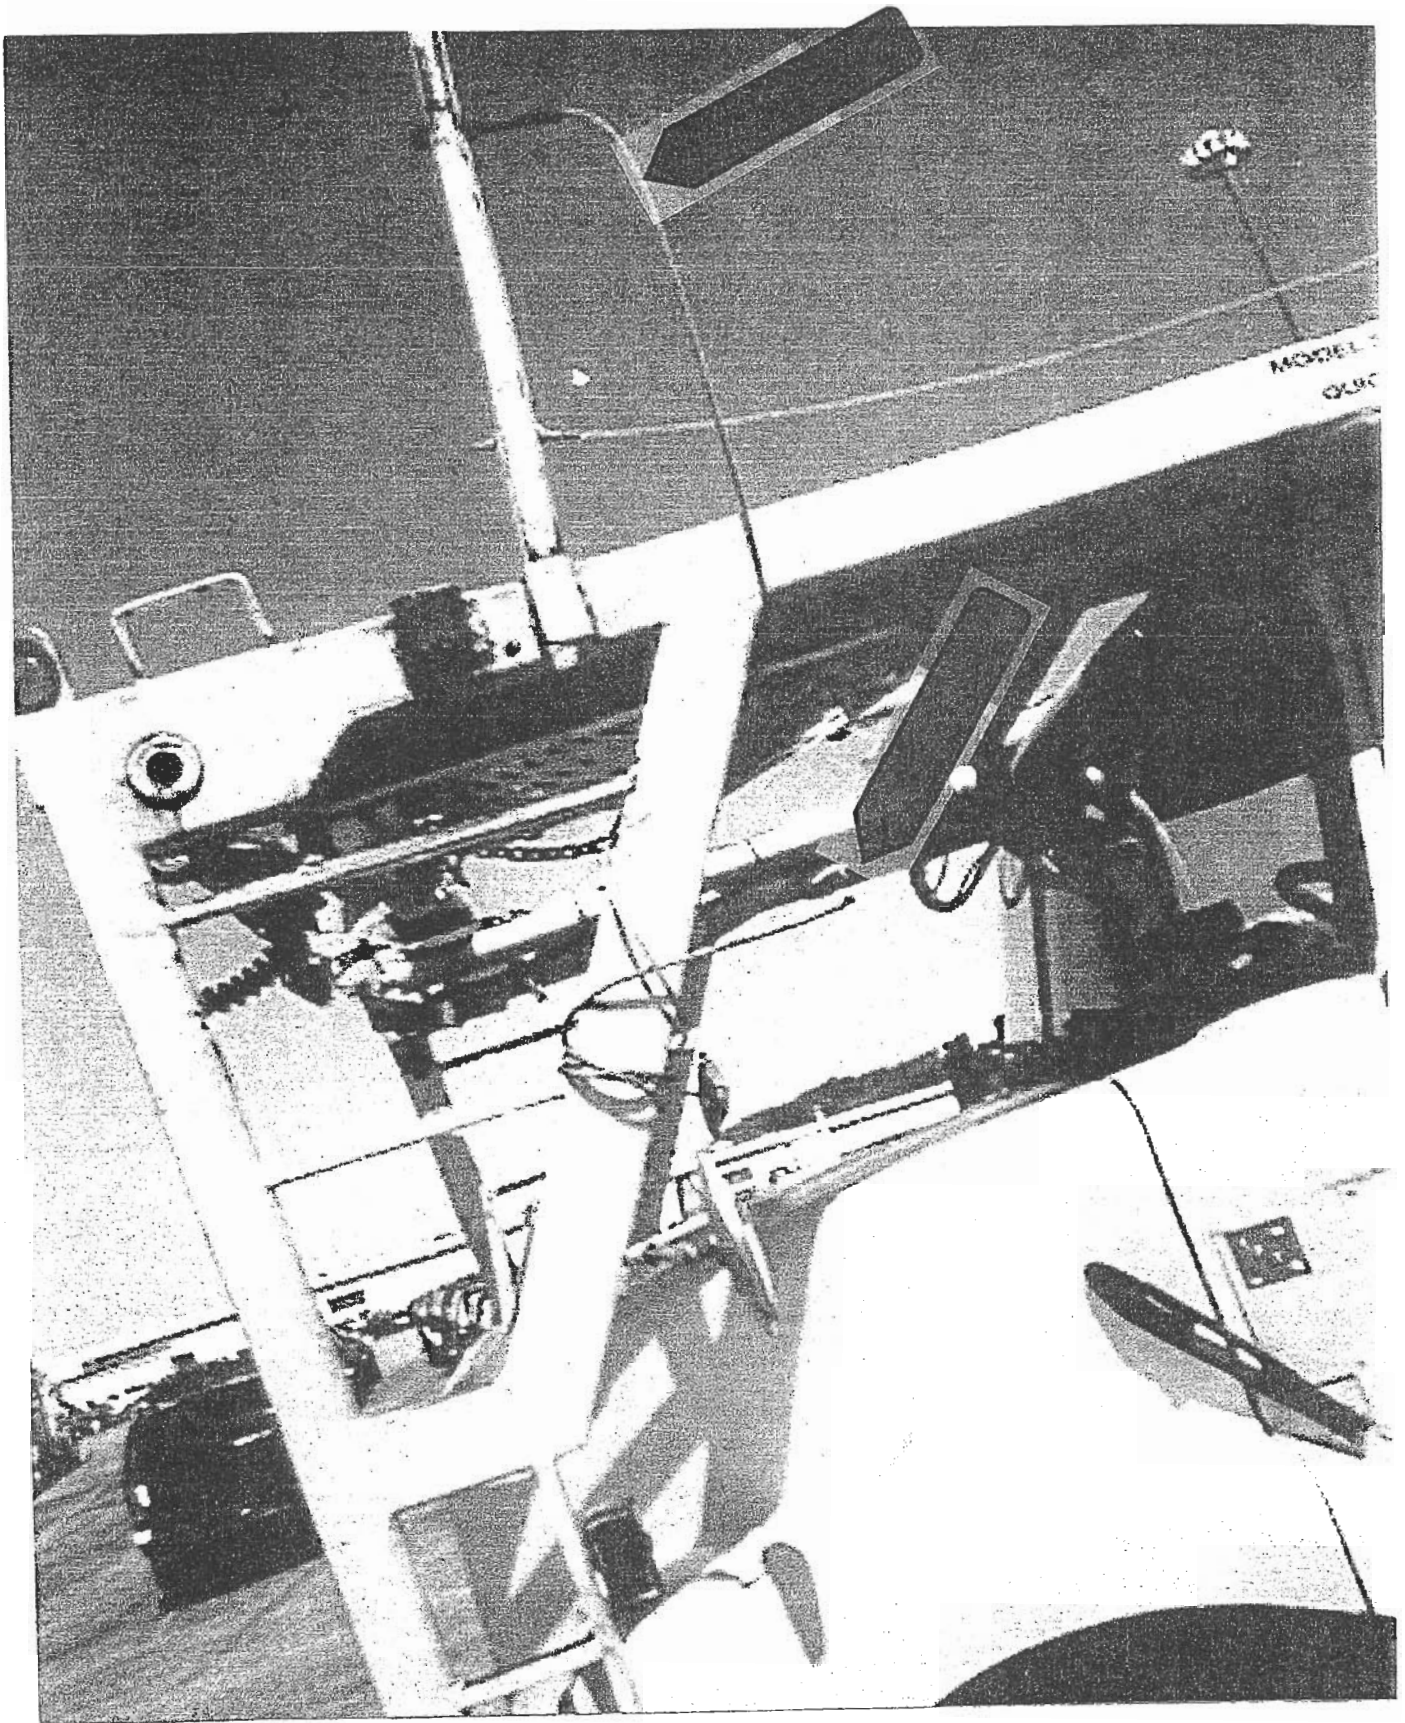
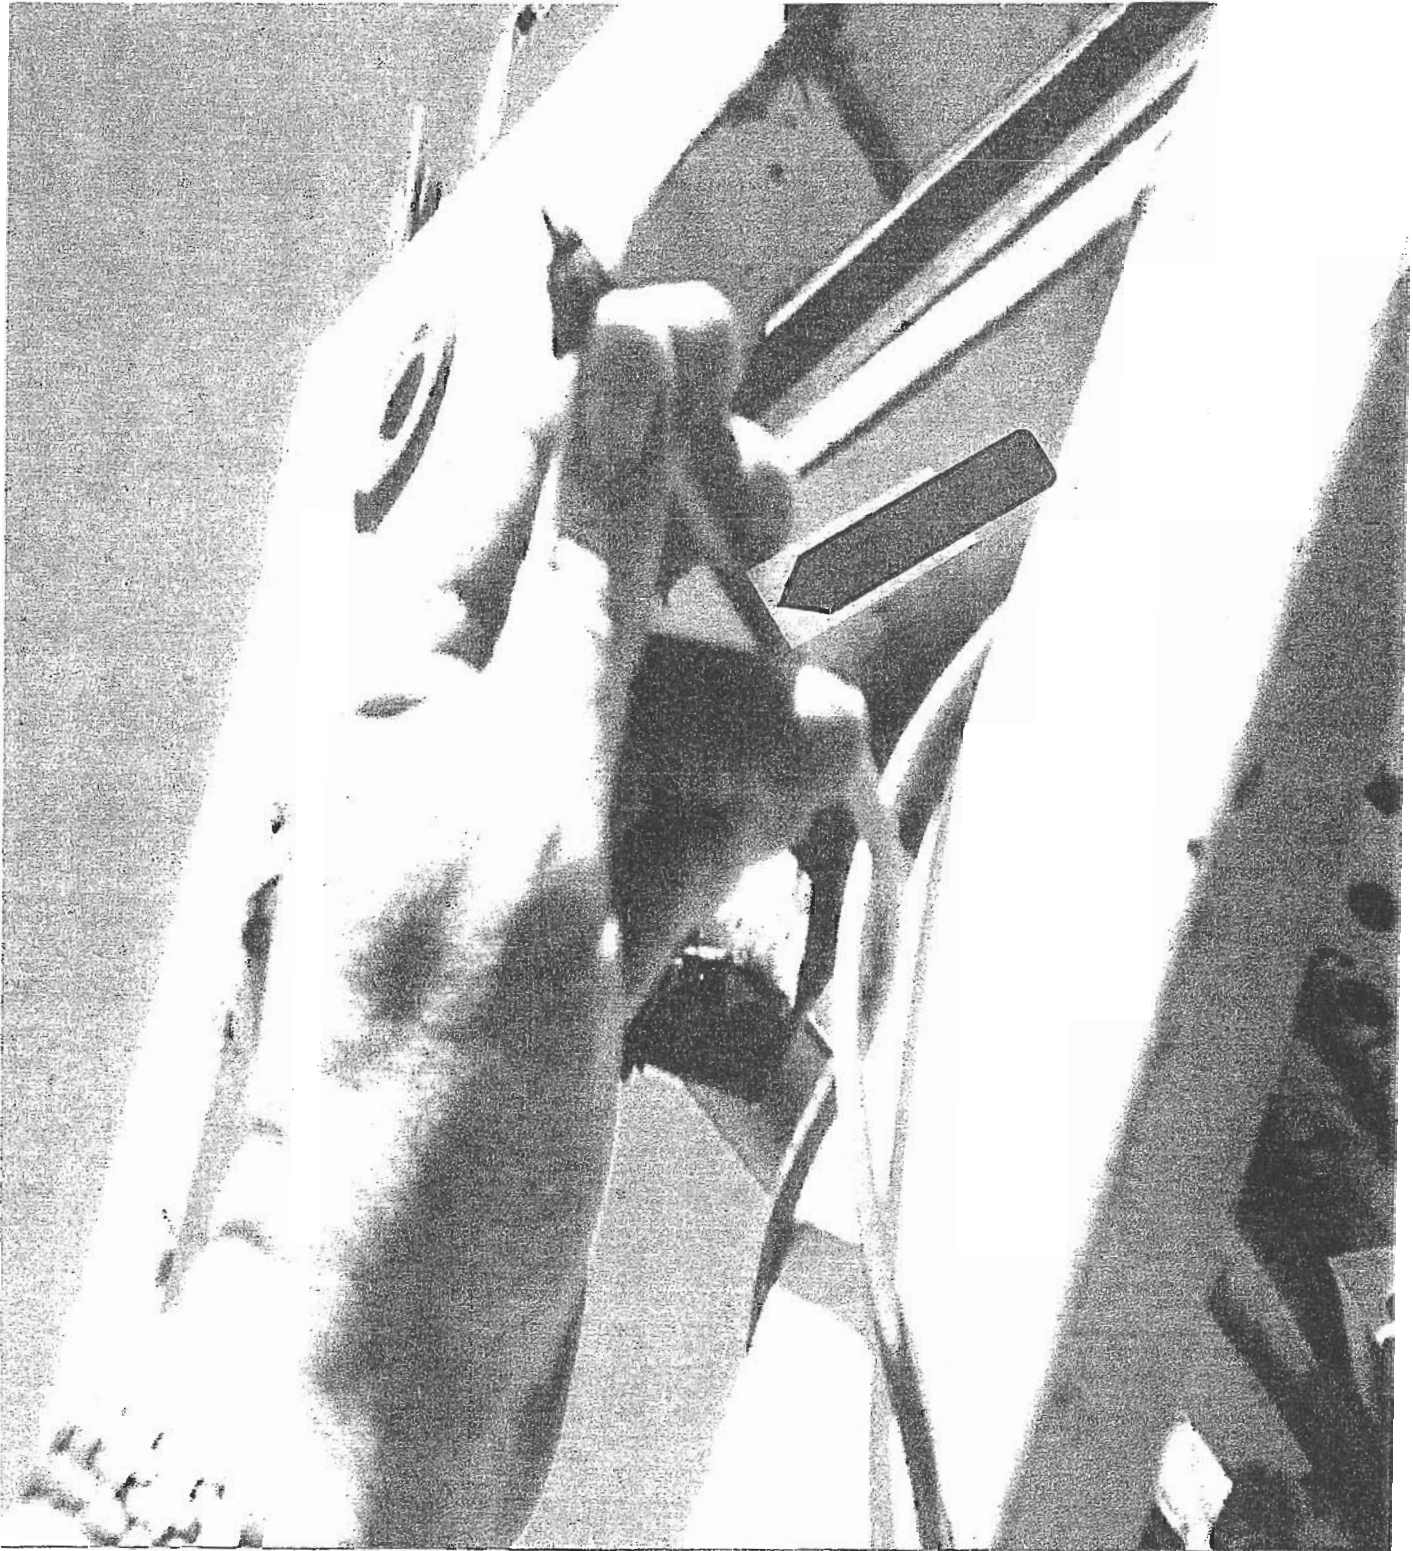
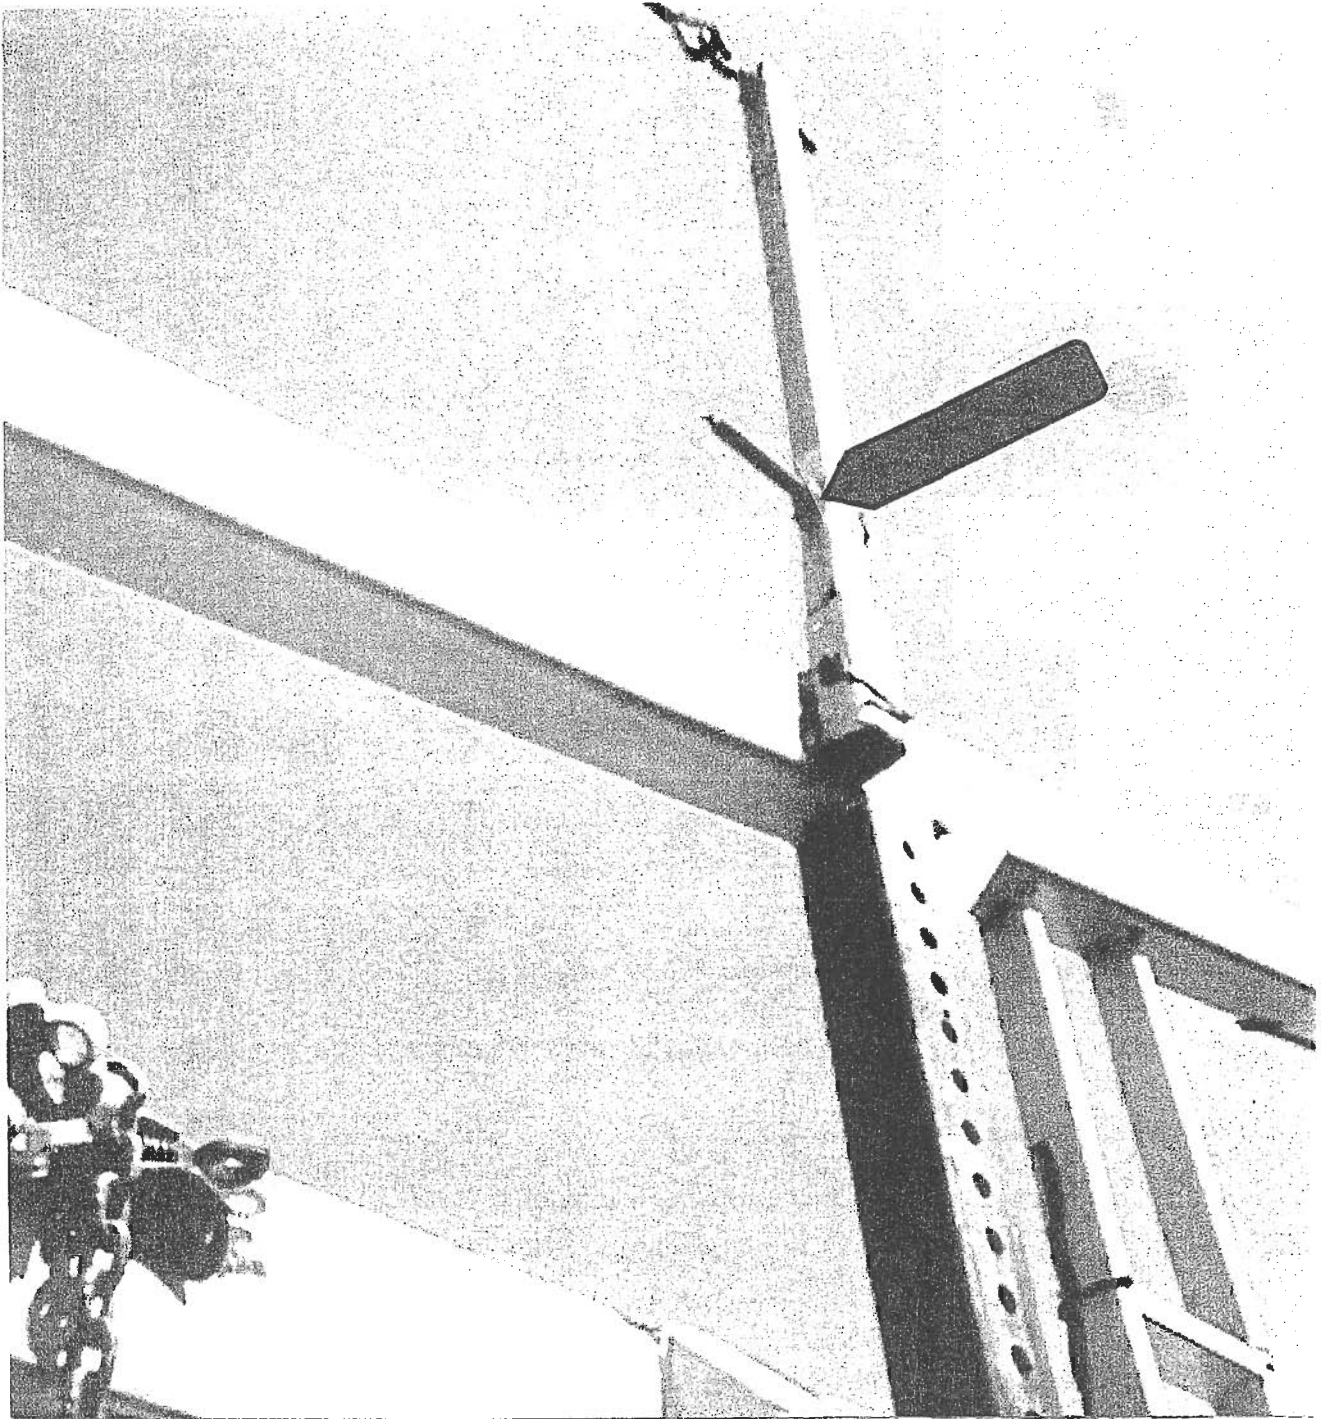
Photographs 1 through 5 are various views of the incident vehicle and cable taken shortly after the incident. Photograph 1 is a view of the vehicle head ramp and reveals the location of the failed safety cable. The red arrows in Photographs 1 through 5 identify the separated cable and the blue arrows identify the swage fitting the cable separated from.

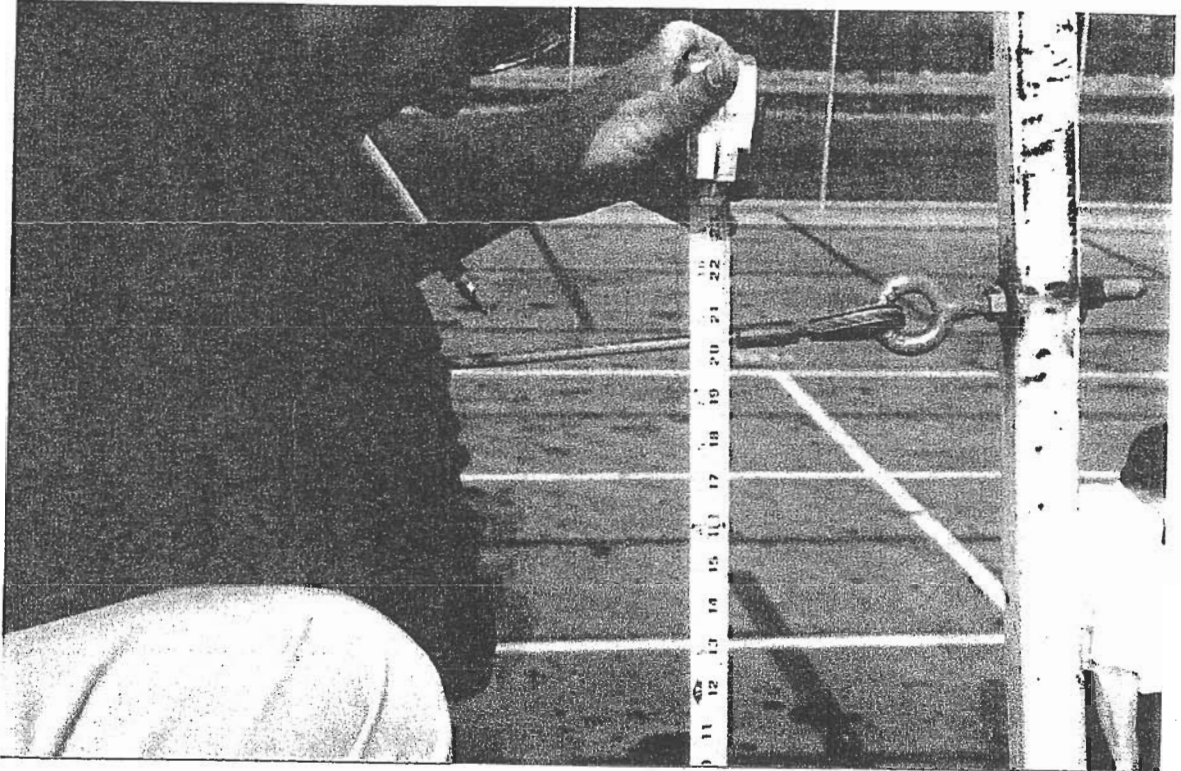
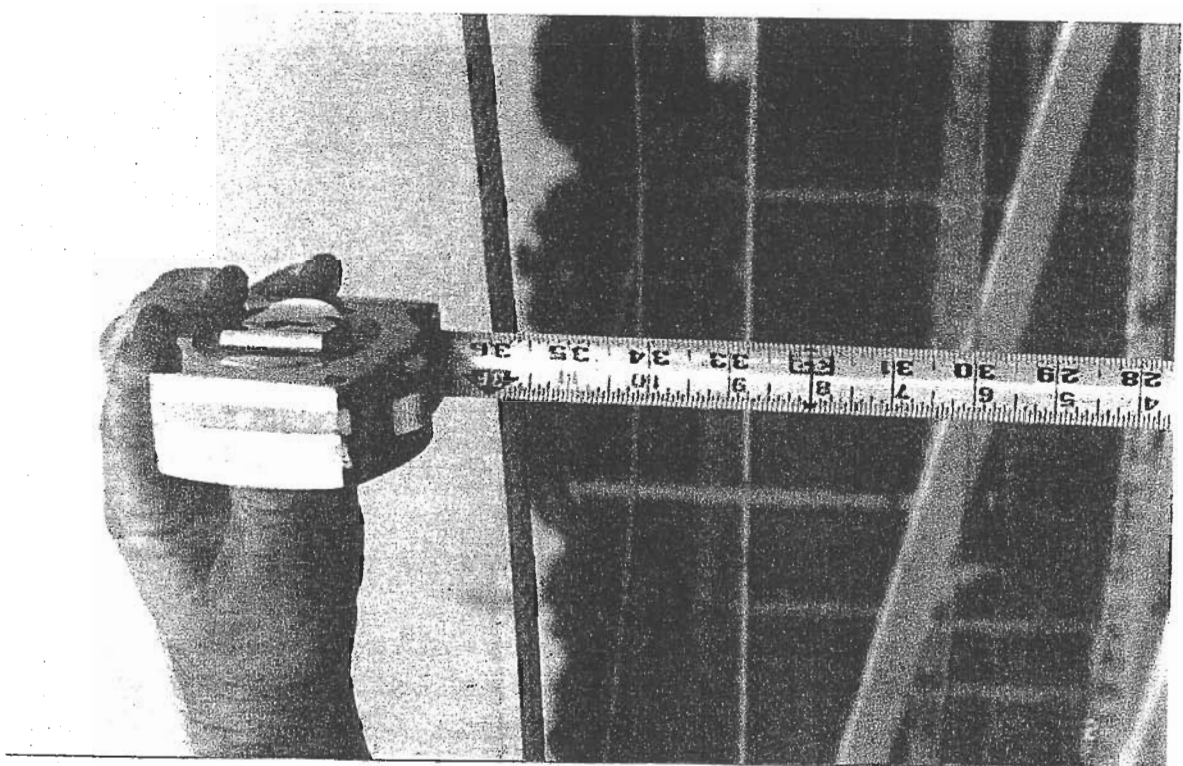
Photographs 12 and 13 are close-up views of the safety cables and reveal the height of the cables from the top deck head ramp. Further, as can be seen from Photographs 11 through 13 the cables are coated with a clear material and that the cables are not rusty.

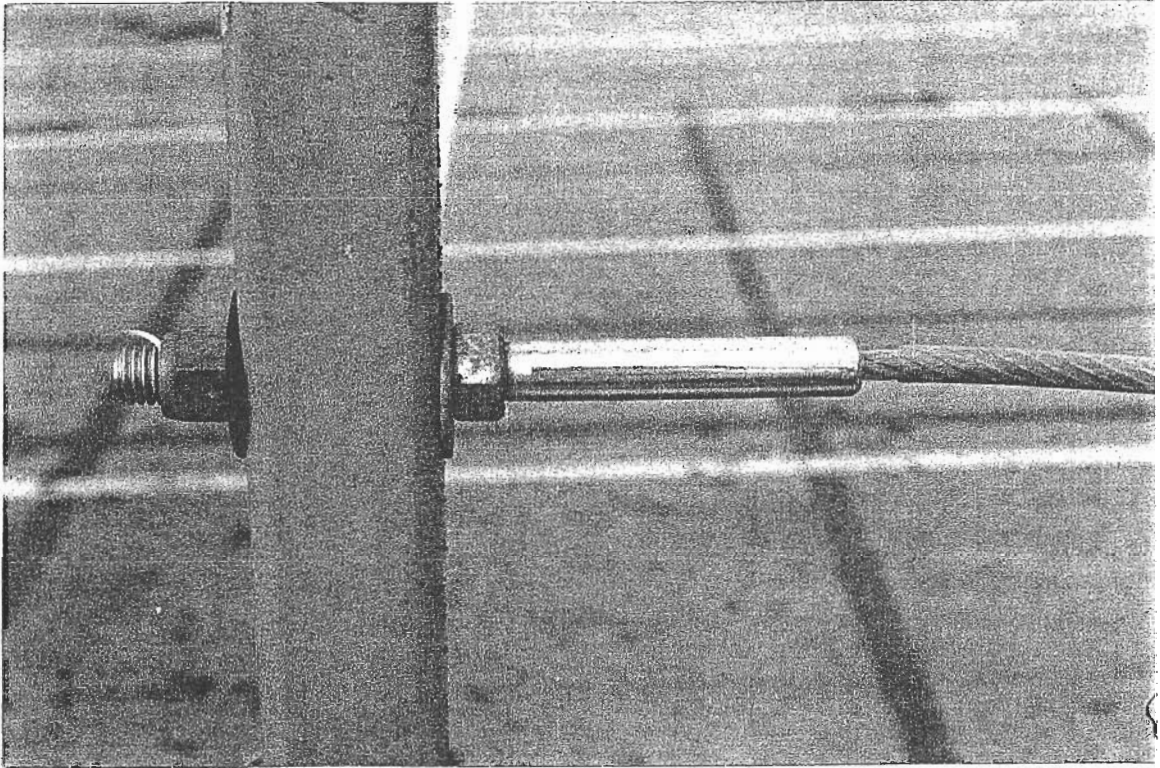
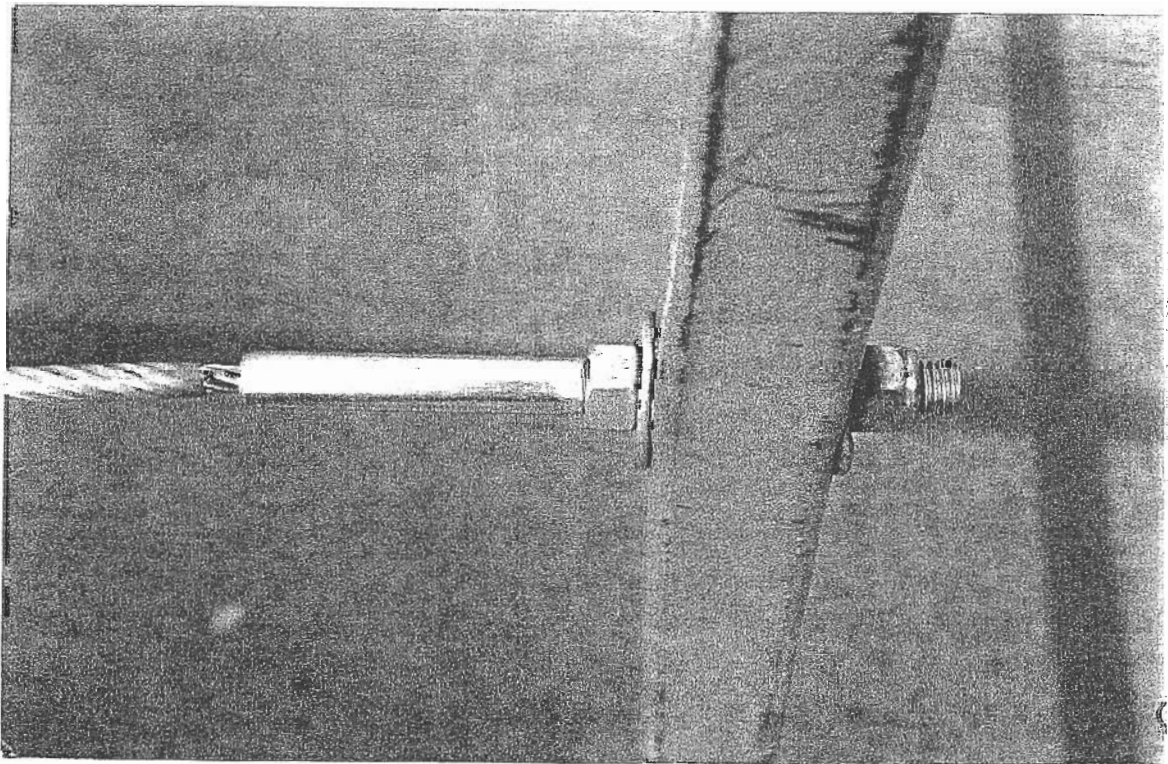
be seen from Photographs 20 and 21 the cable with the stud threaded aircraft fitting is coated with a clear material and that the cables are not rusty. The cable and fitting appear to be made of stainless steel with non-stainless hardware.

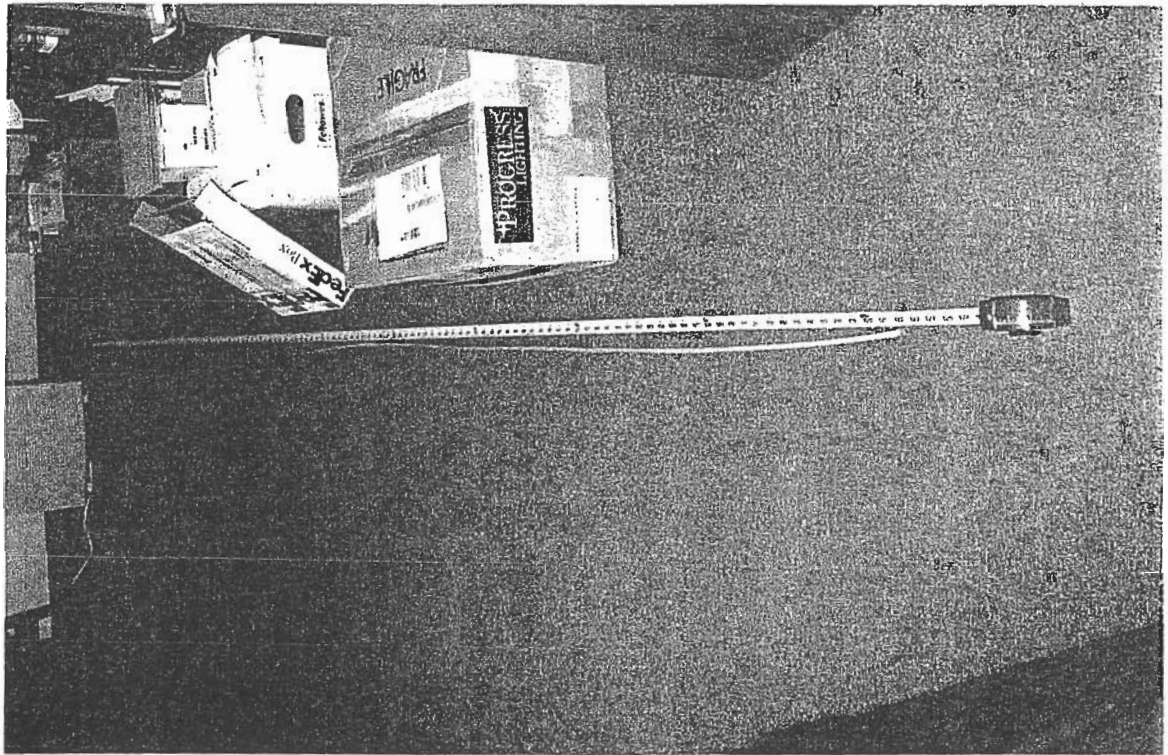
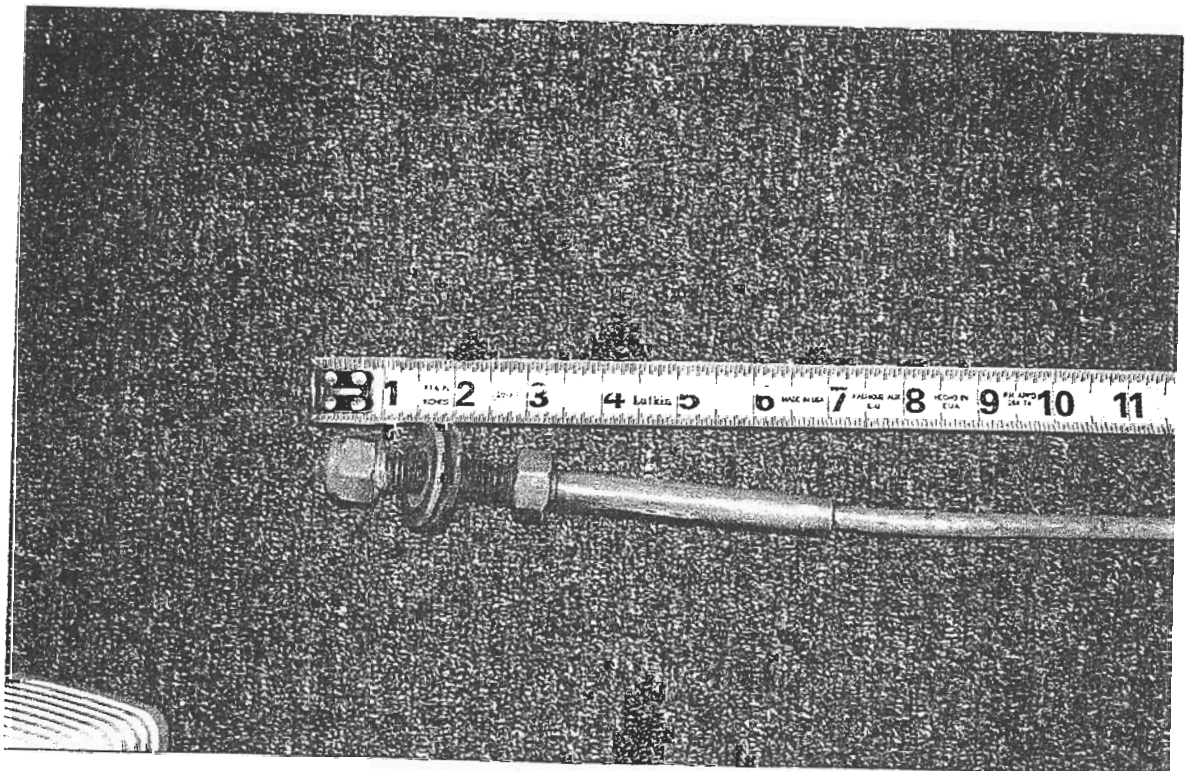
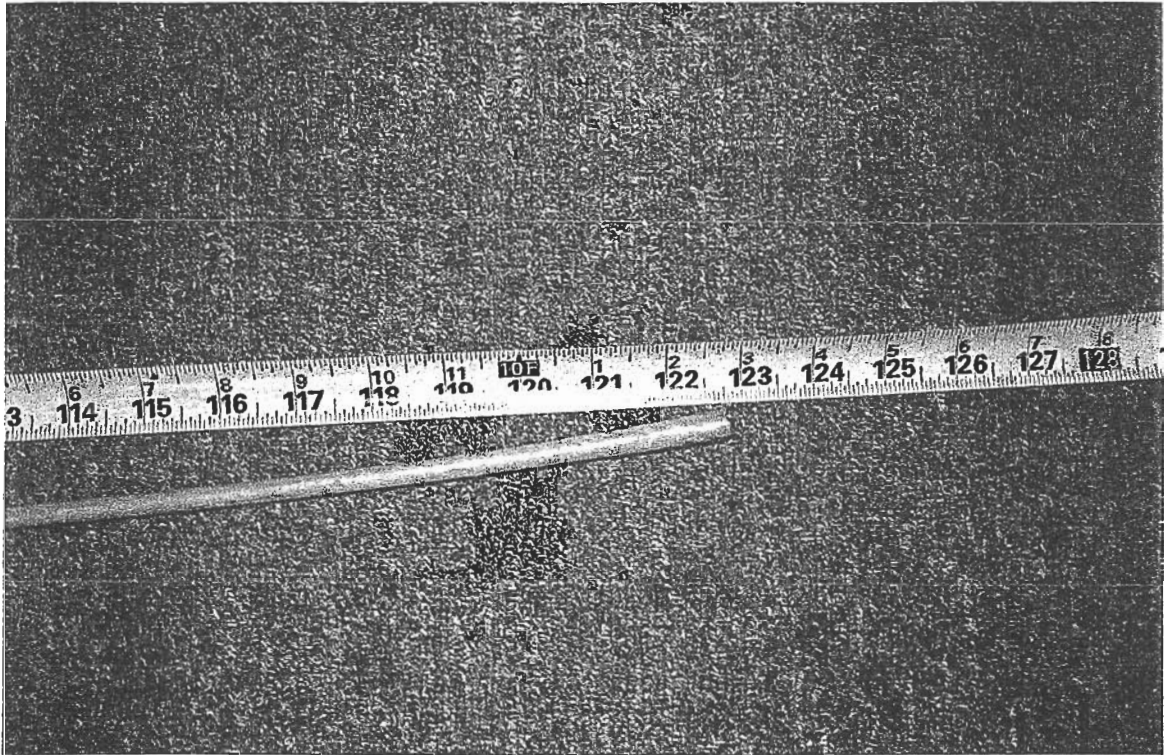
The first cable is documented in Photographs 22 through 38. Photographs 22 through 24 reveal that the cable is failed at one end where it would mate with the swaged fitting. This cable is consistent with the CCI/Hanes specification. Further, the failure of the exemplar cable is consistent with the failure of the incident cable.

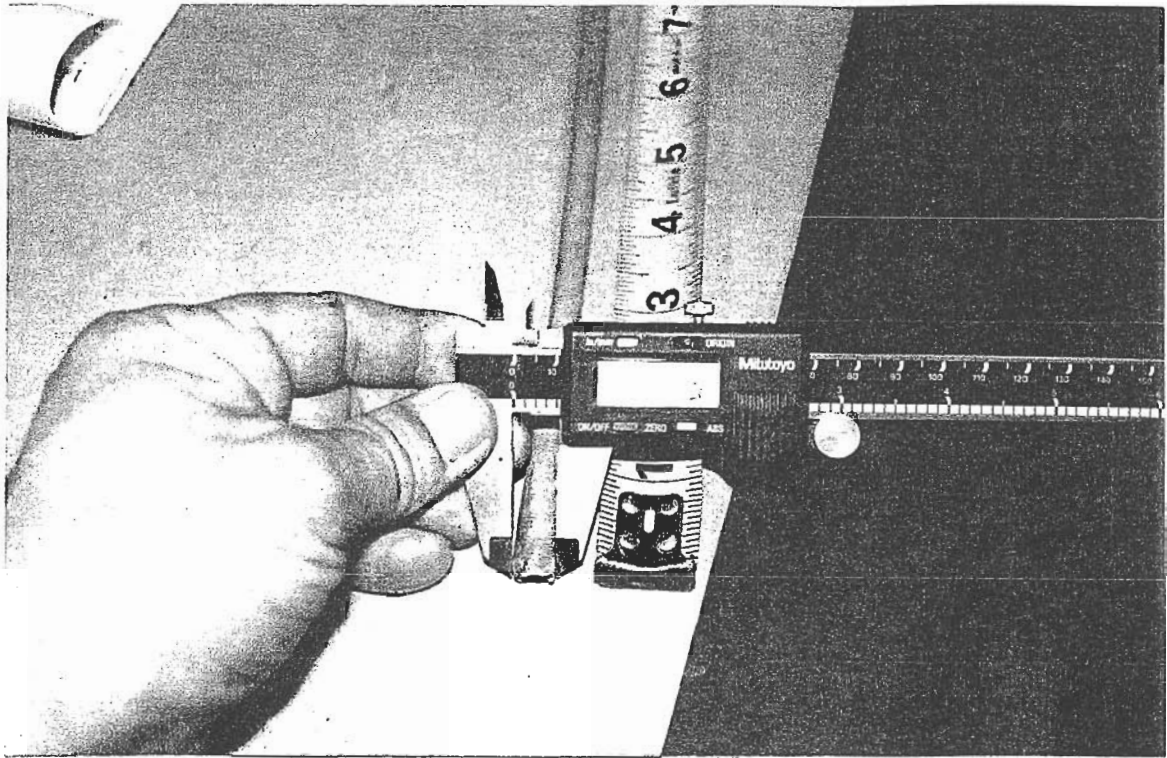
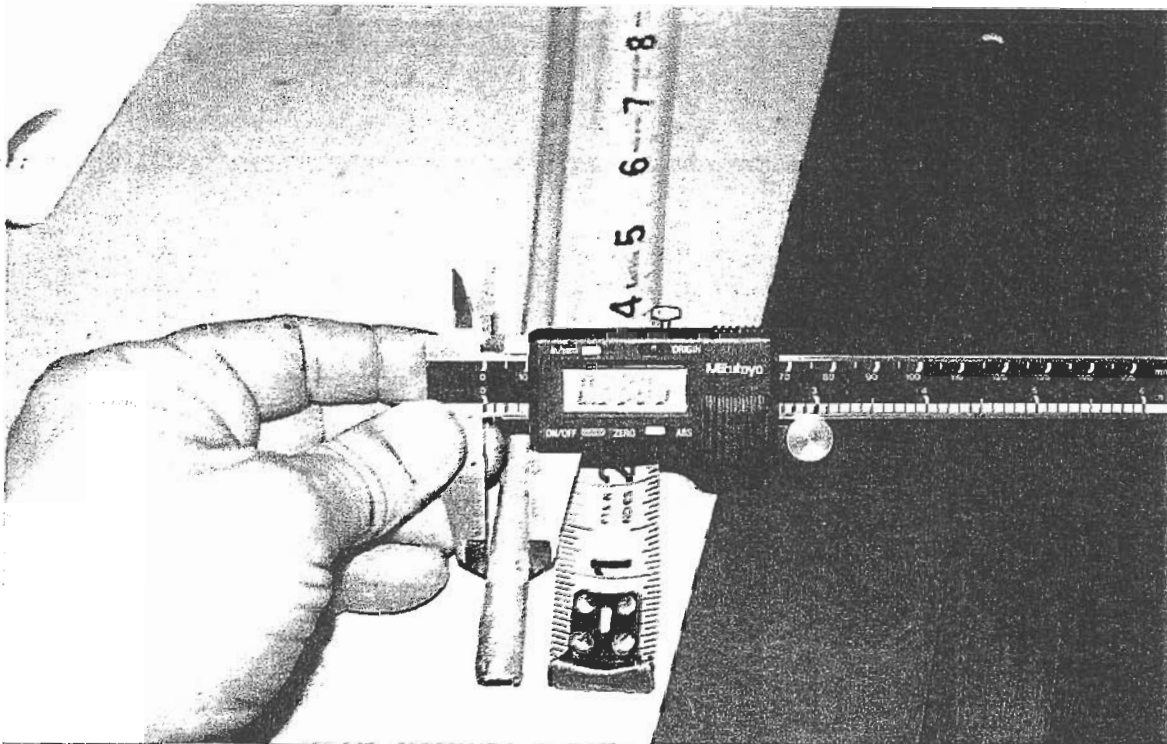
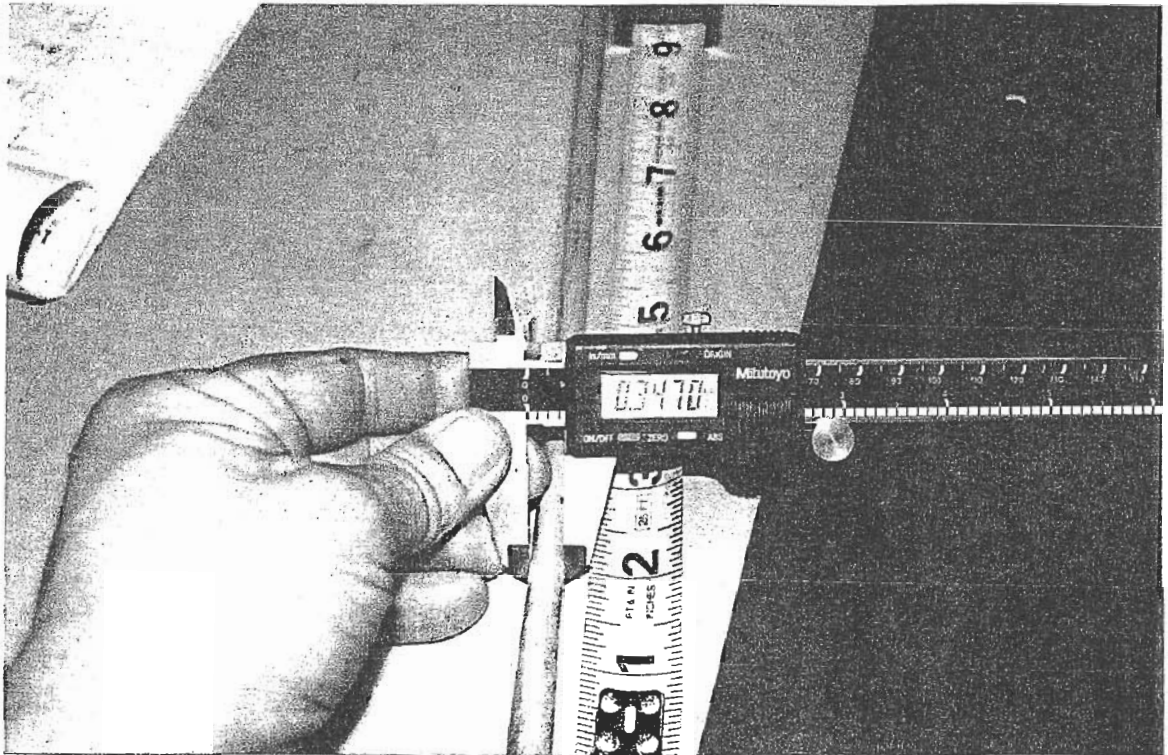
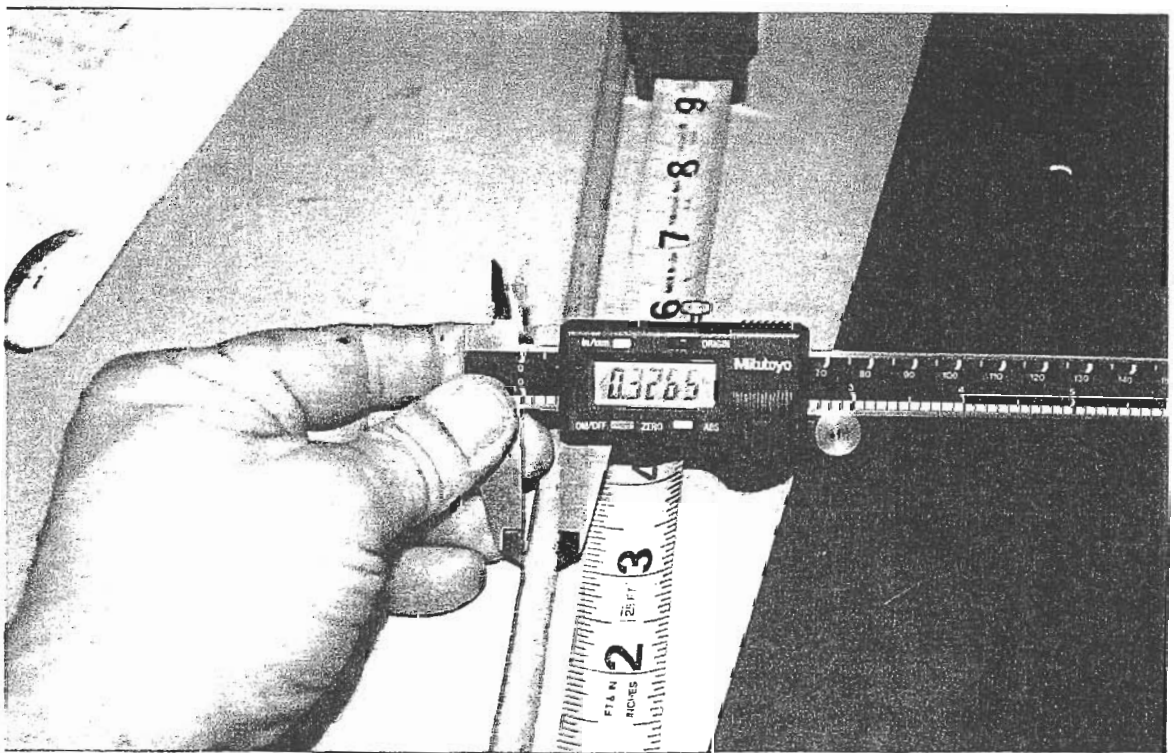
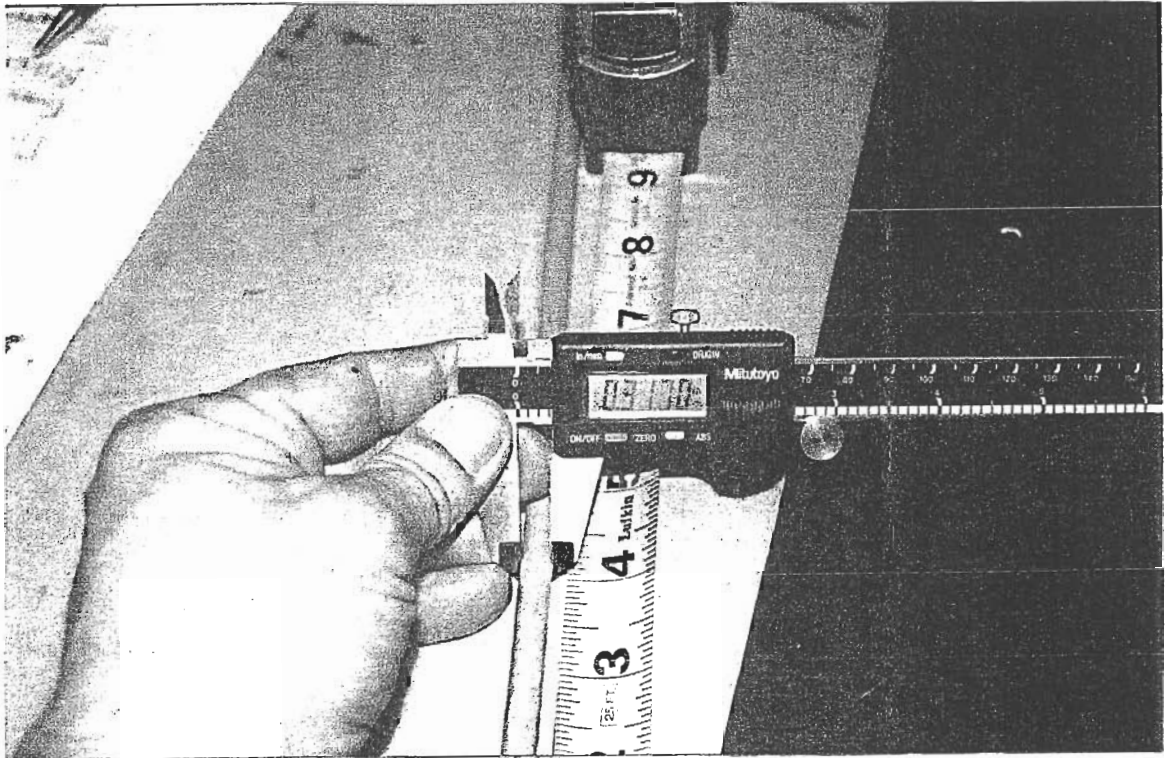
Photographs 26 through 30 document measurements made of the first exemplar cable. The measurements were taken of the cables outer diameter at the failed end. The measurements reveal that at the failed end the cable has an outside diameter of about .42 inches. Away from the failed end the cable has an outside diameter of about .32 inches. Thus, the cable swelled. Further, the swelling is more pronounced toward the failed end of the cable. The swelling observed is due to the growth of corrosion caused by rusting.

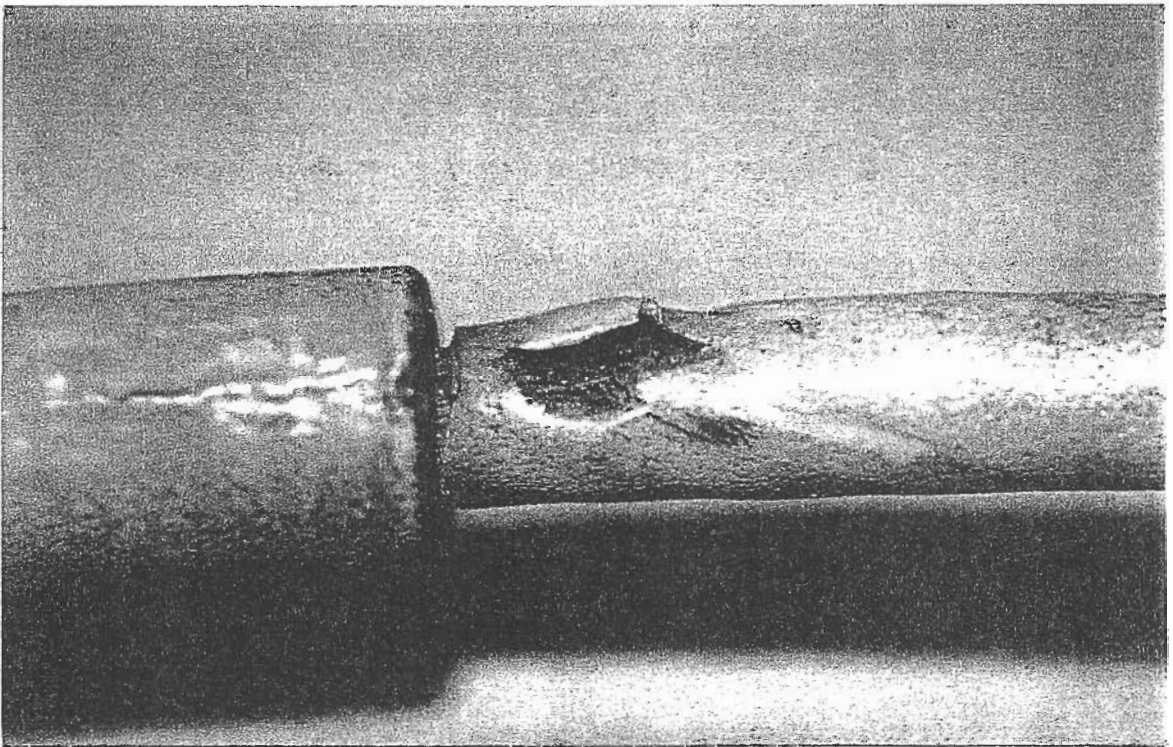
Photographs 32 and 33 are views of the non-failed end of the cable. The photographs reveal that the green painted, yellow coating extends to within about 1/64 of an inch to the swage fitting. Further the photographs reveal the presence of rust. A magnet was utilized to verify that the cable and fitting materials were steel and not stainless steel.
